## **Flexural behavior of reinforced masonry panels**

Juliana T. Oliveira, Joaquim O. Barros

Report 02-DEC/E-10

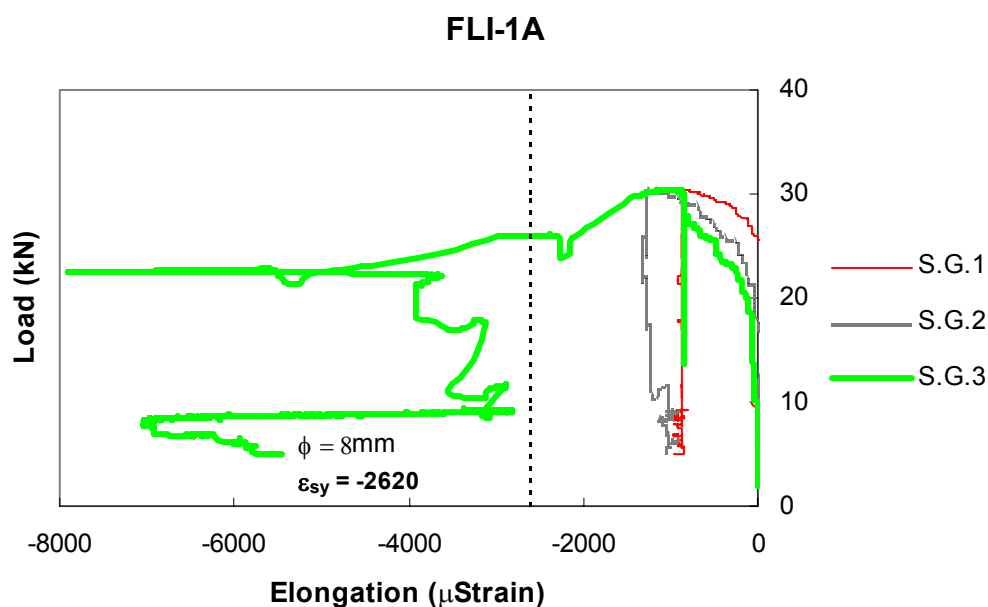
As strain gauge S.G.3 was closer to the failure crack it registered the largest strains. When structural softening was occurring, S.G.3 registered a slip, followed by an increase of strain due to a significant increment of deflection at a load of about 10 kN. During the structural softening phase, S.G.1 and S.G.2 retained the strains measured at the beginning of this phase.

Figure 40 - Force-strain relationship for all strain gauges.

The strain gauges were applied according to the model 2 scheme represented in Figure 8. The force-strain relationship is depicted in Figures 42 and 43.

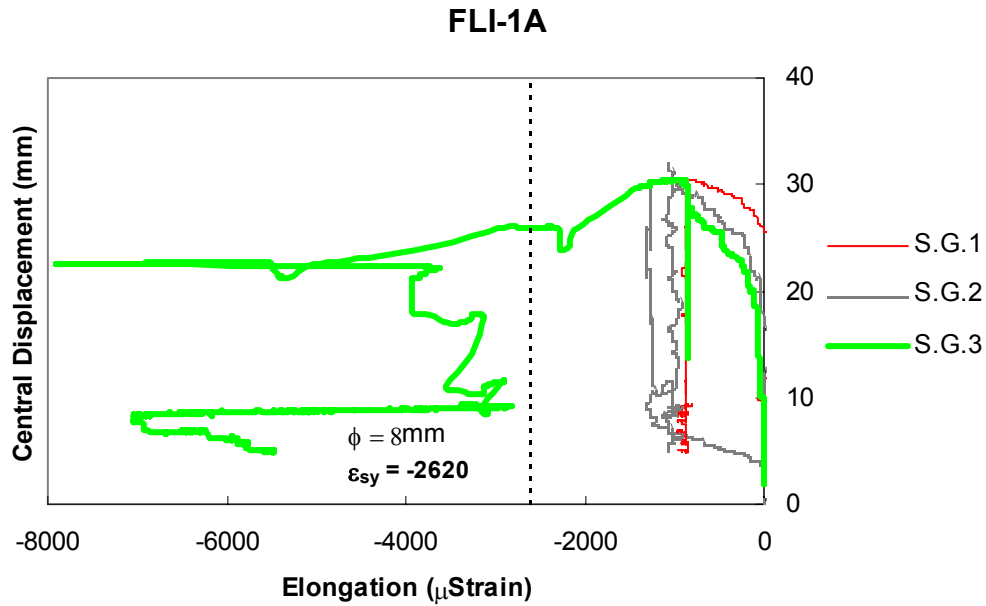
Figure 41 - Relationship between the deflection at panel mid span and the strains at strain gauges.

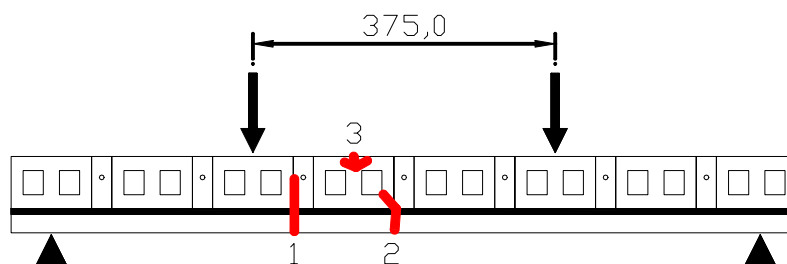
At a load of 27 kN fissure 1 occurred with an abrupt load decay, see Figure 44 and Figure 44. The panel has almost recovered its previous load bearing capacity, and at 25 kN two new fissures became visible (fissures 2 and 3). The welded wire mesh started to rupture at a load of 27 kN and, after the first rupture, other successive ruptures of the mesh were occurred. This process can be seen in graphic of Figure 43.

Fissure 2 has crossed the brick and, at failure, the horizontal top wall of this brick was crushed, see Figure 44. At panel bottom surface and at concrete layer/brick interface the crack width of fissure 2 was 15 mm and 10 mm, respectively.

Figure 42 – Crack pattern in FLI-2A.

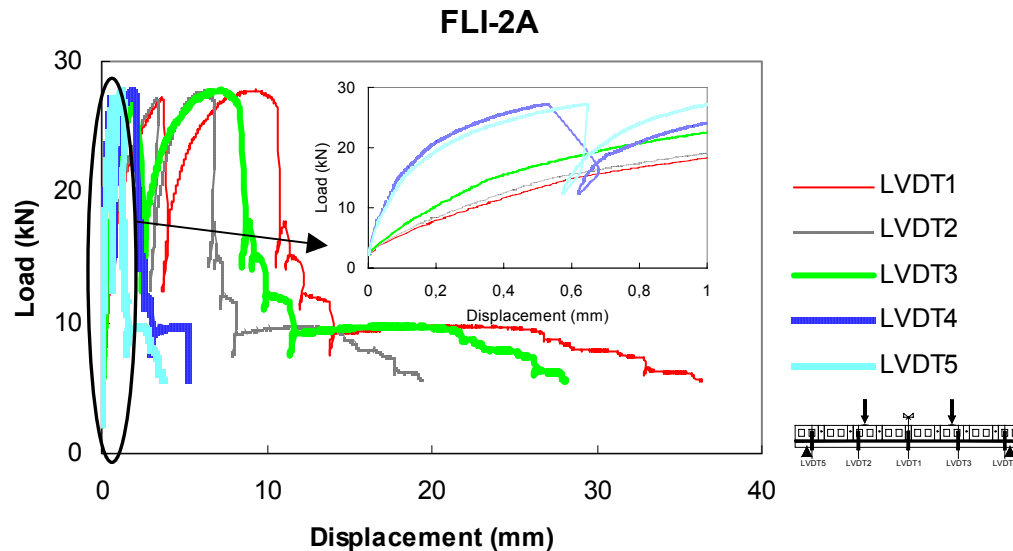
Due to crack failure position, LVDTs 3 and 4 registered displacements larger than the corresponding LVDTs positioned symmetrically (LVDTs 2 and 5), see Figure 43 and Figure 43.

Figure 43 – Force-displacements relationship for all LVDTs.

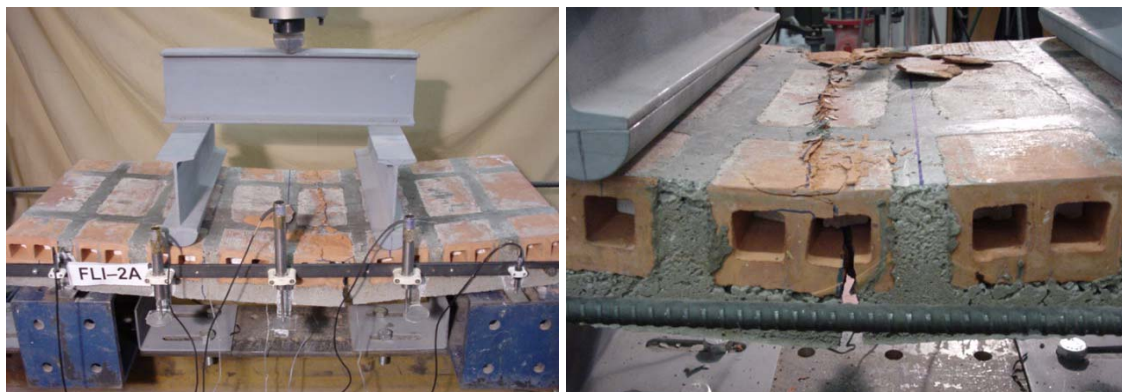
Figure 44 – Aspect of the panel FLI-2A after have been tested.

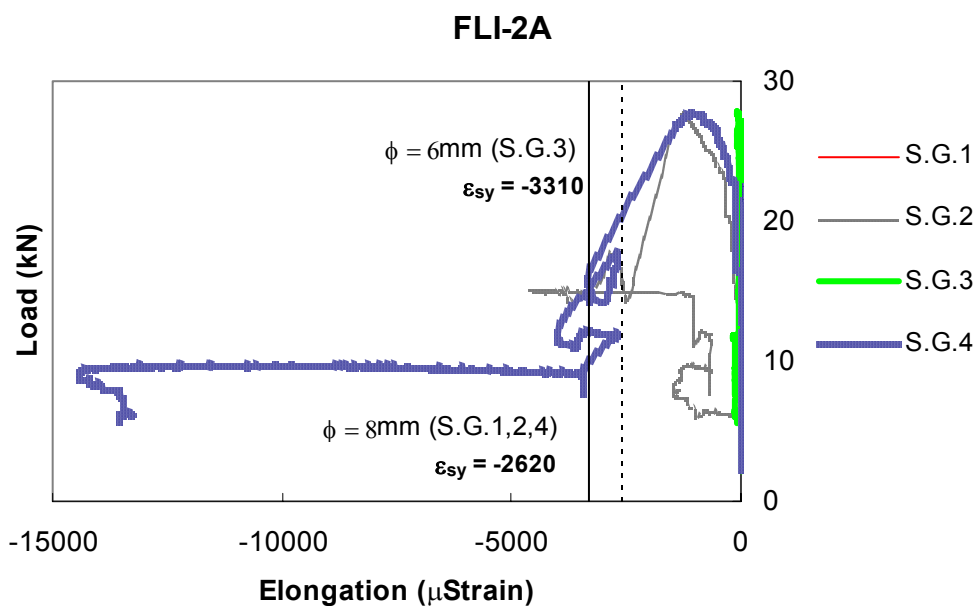
The strain gauges were placed according to model 1 of Figure 8. As strain gauge 3 was fixed in a transversal bar, very low strain values were registered, see Figure 45. Despite strain gauges 2 and 4 (S.G.2 and S.G.4) have been positioned in the same alignment, the values registered by S.G.4 were larger. Graphic of Figure 45 shows that the steel bar where S.G.4 was fixed started to yield at an elongation near  $2.62 \times 10^{-3}$ , which is a close value to the yield strain registered in the uniaxial tensile tests, see Annex 1.

Figure 45 – Force-strain relationship for all strain gauges.

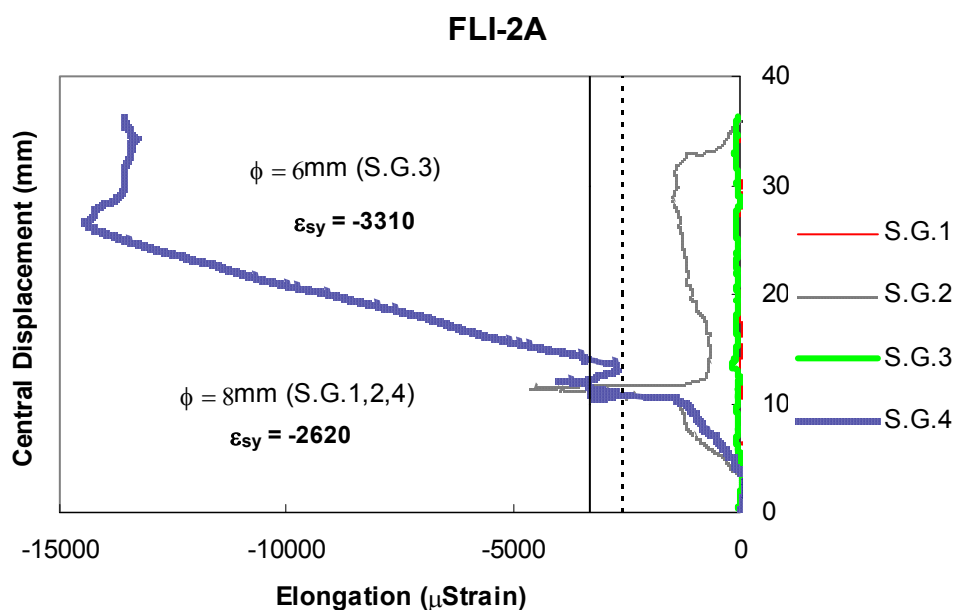
Figure 46 – Relationship between the deflection at panel mid span and the strains at strain gauges.

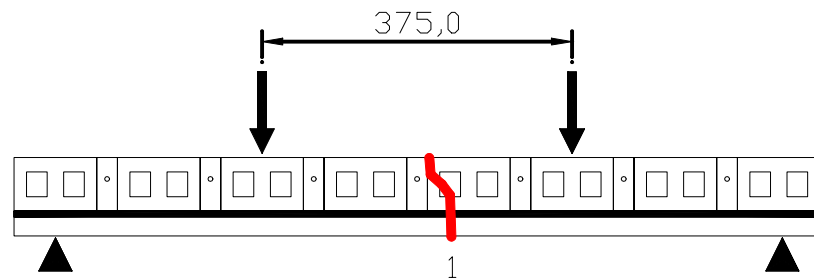
In this panel only one crack occurred, at a load of 20 kN, see Figure 47. At a load of about 26 kN wires of the mesh crossing the crack have ruptured. At panel rear

face the crack opening was larger than at panel front face. During the phase corresponding to the post-peak force-deflection branch some wires of the mesh were ruptured, followed by load decay up to a minimum value of 4 kN. At the end of the test, the crack opening of fissure 1 at panel bottom surface was 15 mm and 20 mm at front and back side of the panel.

Figure 47 – Crack pattern in FLI-3A.

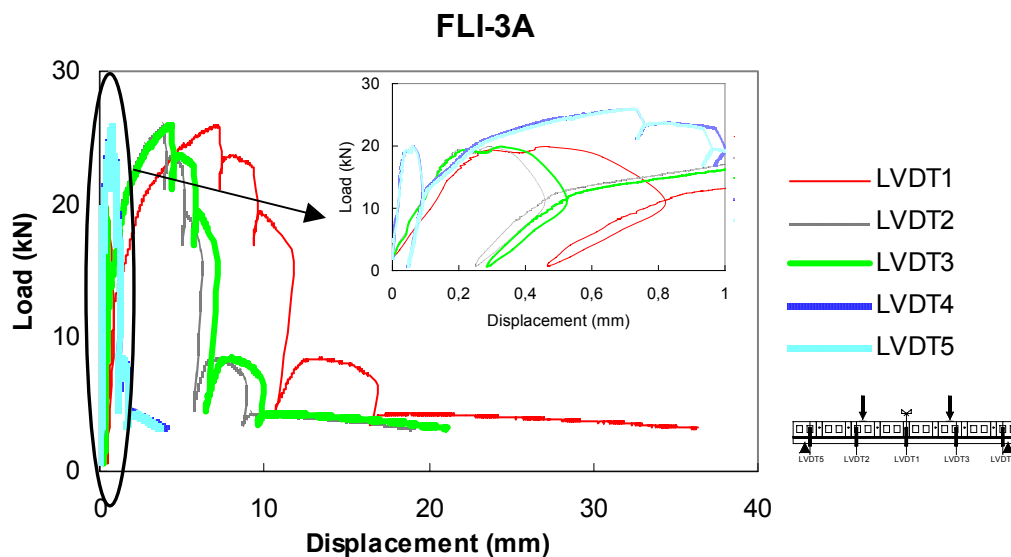
Due to the fact that only one fissure has occurred and it was positioned near the panel center, similar displacements were registered by LVDTs equidistant from the panel center, see Figure 48.

Figure 48 – Force-displacements relationship for all LVDTs.

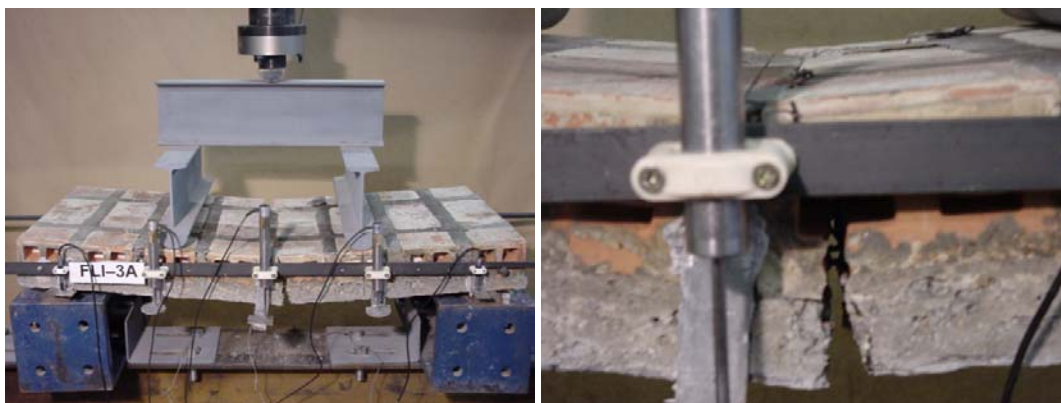
The failure configuration of panel FLI-3A is shown in Figure 49.

Figure 49 – Aspect of the panel FLI-3A after have been tested.

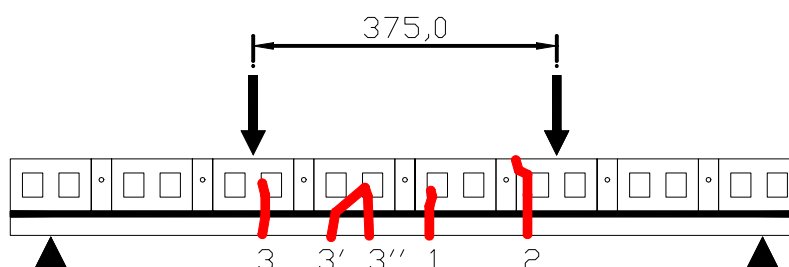
Figure 50 represents the crack pattern developed in panel FLI-4A. A total of five fissures occurred. The occurrence of a fissure induced load decay, as it can be seen in the graphic force-deflection relationship of Figure 51. Fissure 1 was the first one to occur, at a load of 21 kN. For a load a little above 21 kN occurred fissure 2 followed by rupture of some wires of the mesh. Fissures 3, 3' and 3'' appeared almost simultaneously at a load around 29 kN. In between 20 kN and 29 kN, fissure 2 opened significantly. At panel rupture, the superior part of the bricks crossed by fissure 2 was crushed. This fissure attained 15 mm and 10 mm of crack opening at panel bottom surface and at concrete layer/brick interface, respectively. These crack opening values were observed in front and rear sides of the panel.

Figure 50 – Crack pattern in FLI-4A.

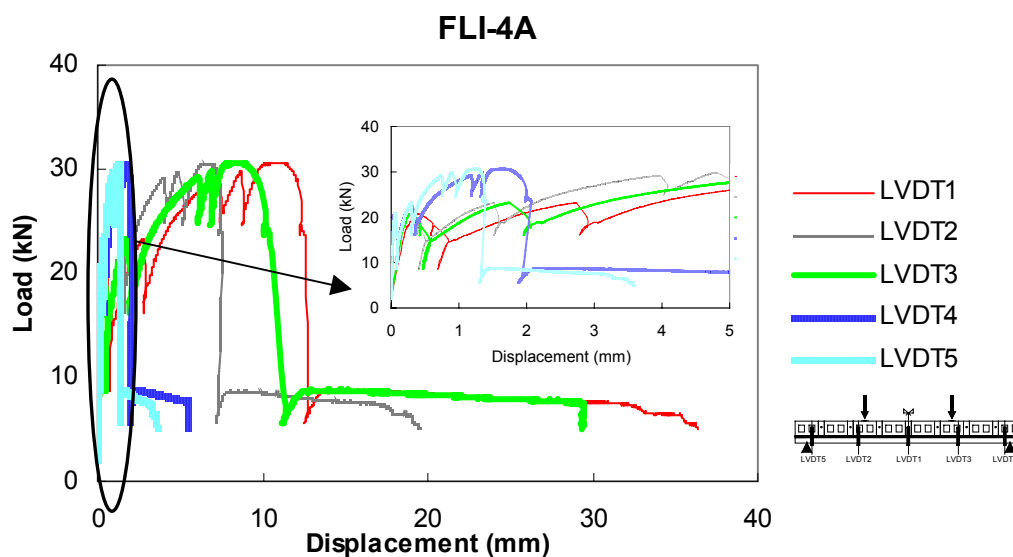
As LVDT 3 was positioned closer to the failure crack (fissure 2) than its symmetrical transducer (LVDT 2), it registered larger displacements. Similar reasons justify LVDT 4 has measured larger displacements than LVDT 5.

Figure 51 – Force-displacements relationship for all LVDTs.

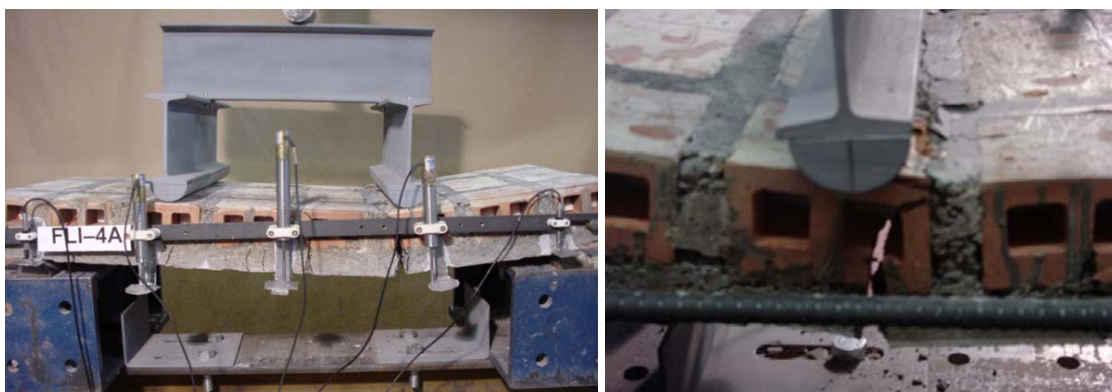
The failure configuration of panel FLI-4A is shown in Figure 52.

Figure 52 – Aspect of the panel FLI-4A after have been tested.

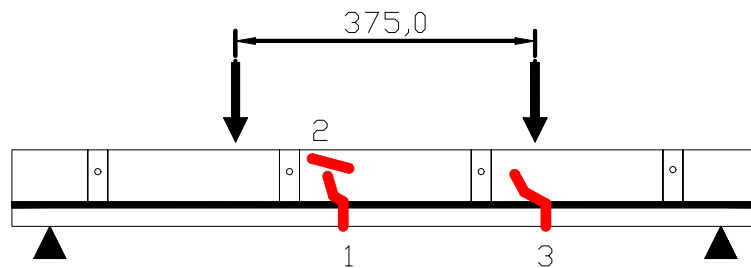
The main difference between series FLI-B and series FL-B (section 4.2) is that, when tested, panel of series FLI-B was positioned in such a way that concrete layer was submitted to tensile stresses. At a load of 30 kN occurred successive ruptures of the welded wire mesh, as well as, a diagonal crack in the brick, near the panel upper face. The final crack pattern of panel FLI-B is represented in Figure 53. First crack (fissure 1) occurred at a load of about 22 kN, while fissures 2 and 3 occurred almost

Figure 53 – Crack pattern in FLI-1B.

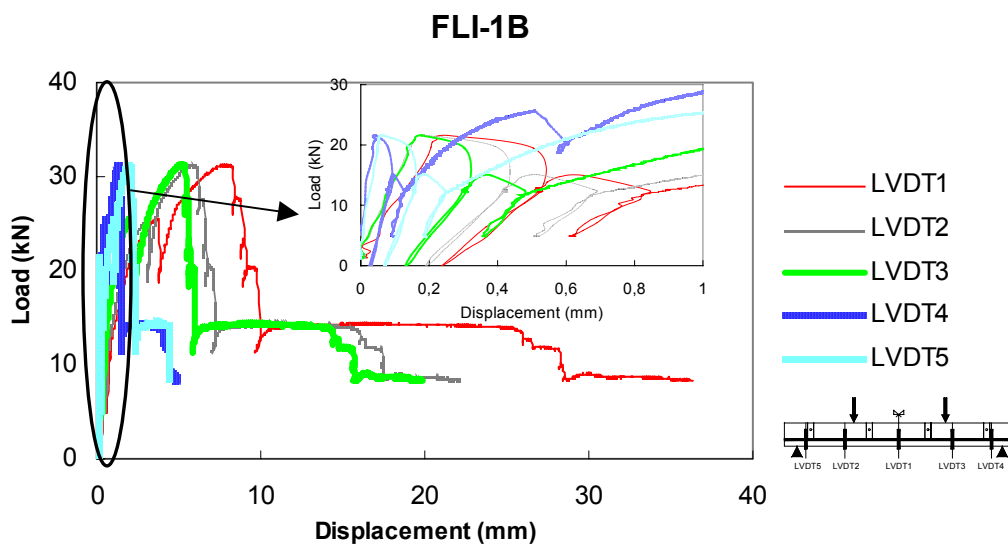
simultaneously for a load about 26 kN, see Figure 54. At 30 kN, due to high compression stresses in the cracked brick, an inclined crack (fissure 2) was formed above the crack mouth of fissure 1. For the same load level some wires of the mesh were ruptured, which induced the load drops observed in Figure 54. At panel failure the volume of brick above fissure 2 was crushed, see Figure 55. Due to the position of the cracks, the LVDTs at right side of the panel (from front view) registered larger displacements than the corresponding ones at left side.

Figure 54 – Force-displacements relationship for all LVDTs.

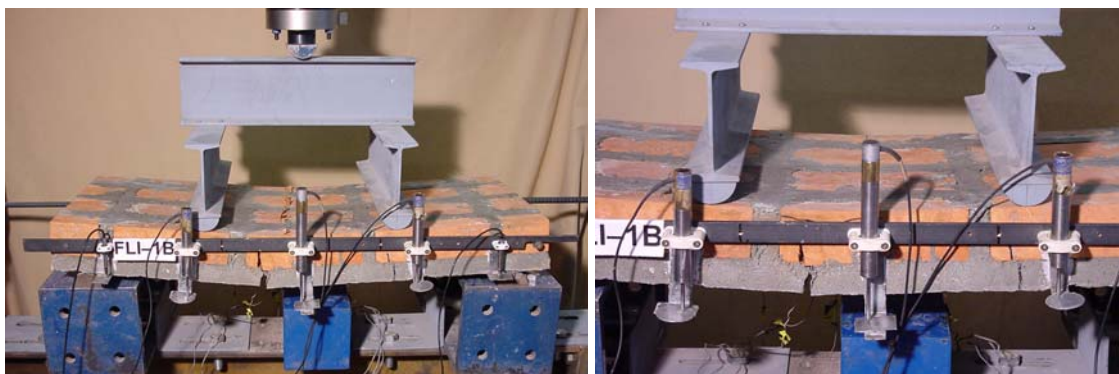
Figure 55 – Aspect of the panel FLI-1B after have been tested.

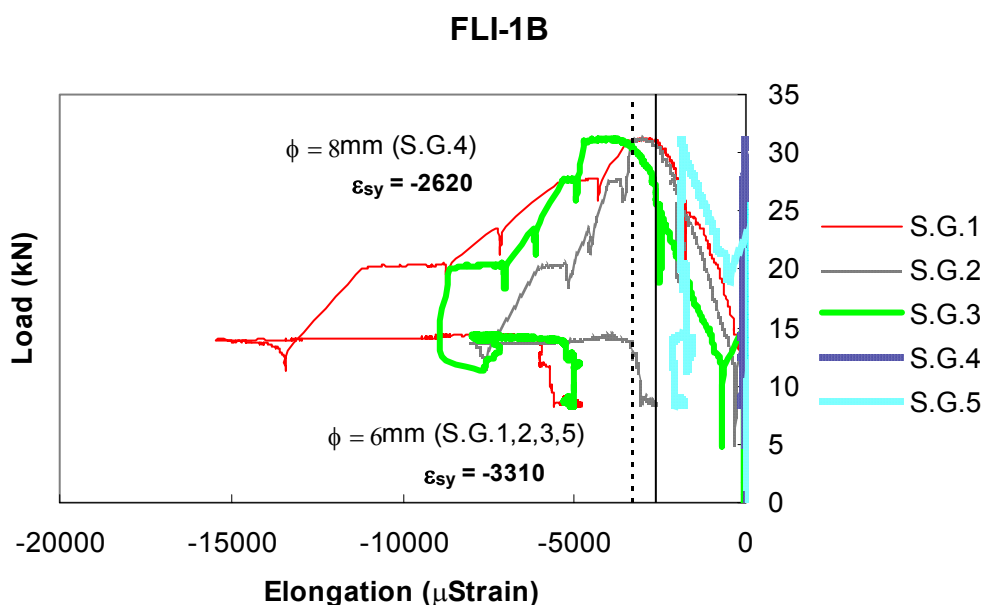
Figures 58 and 59 represent the evolution of the strains measured in the strain gauges positioned according to model 1 of Figure 9. The strain gauges S.G.1, S.G.2 and S.G.3, placed at panel mid span, registered yielding of the corresponding bars for a load level of about 30 kN. In spite of S.G.5 have been near the fissure 3, the corresponding bar has not yielded at this section because, when the panel entered in the structural softening phase, the crack opening of fissure 3 remained almost constant, while failure crack was opening.

Figure 56 – Force-strain relationship for all strain gauges.

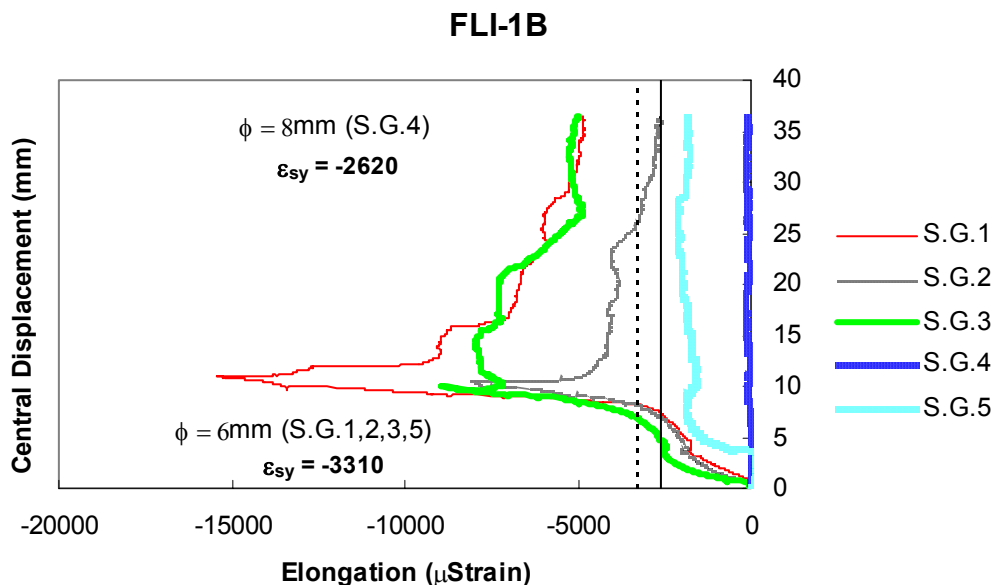
Figure 57 - Relationship between the deflection at panel mid span and the strains at strain gauges.

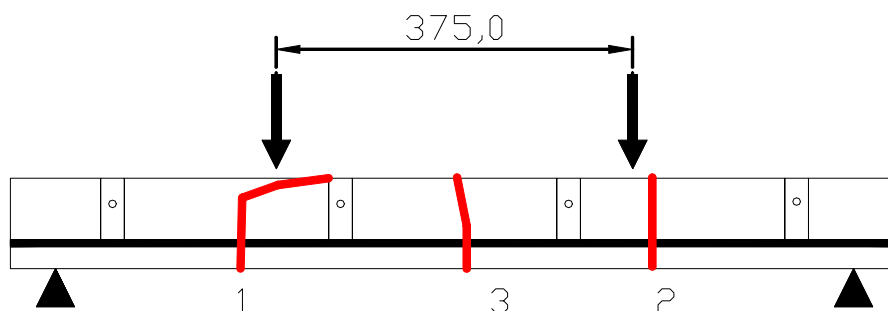
Figure 60 represents the final crack pattern observed at the end of the test of panel FLI-2B. The first fissure (number 1) occurred at a load level of about 28 kN, followed by a load decay. At a load of 26 kN appeared the fissure 2, in the symmetrical position of fissure 1, followed by a second drop on the panel load bearing capacity. At a load level of 30 kN arose a fissure at panel mid span followed by crushing of the concrete joint just at right of the left line load, see Figure 60.

Figure 58 - Fissures configuration.

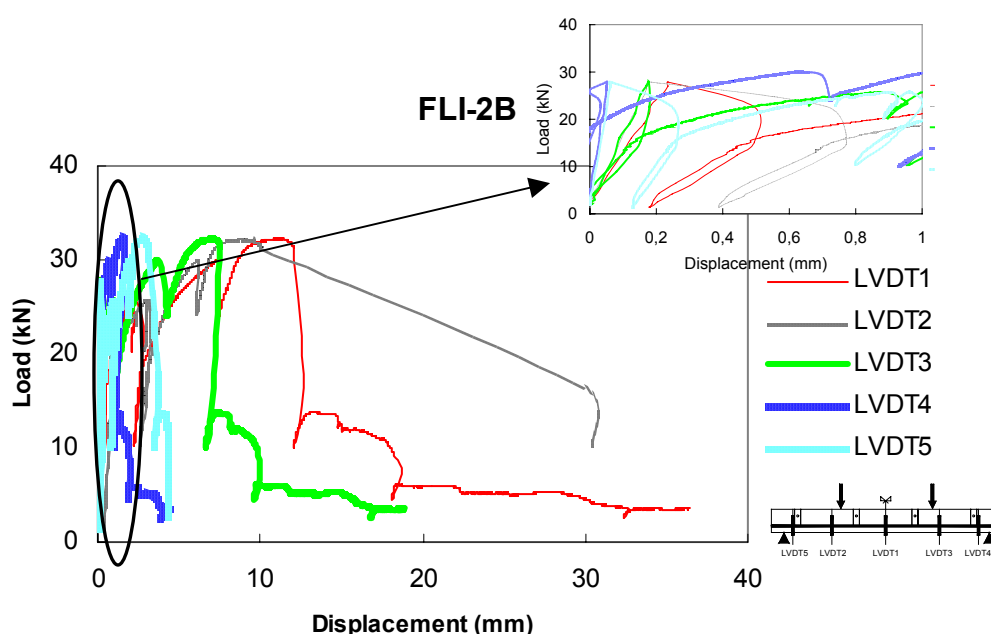
At a load level of 32 kN, the crack opening of fissure 1 increased significantly and wires of the mesh have ruptured, having the panel lost its capacity to support loads above 5 kN. Above 10 mm of deflection the values registered by LVDT 2 are not real because the plate support of this LVDT has dropped, see Figure 60. The panel section where LVDT 5 was positioned deflected more than 5 mm. As the measuring length of LVDT 5 was 5 mm, the deflections above 5 mm were not registered.

Figure 59 – Force-displacements relationship for all LVDTs.

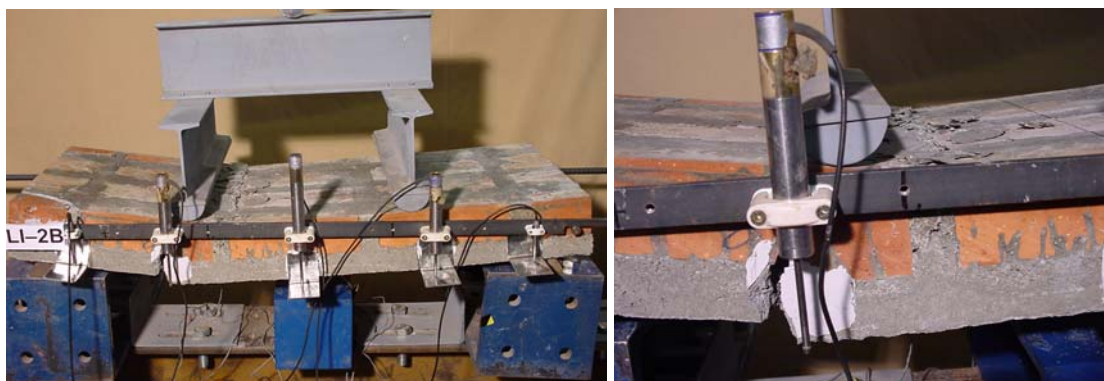
Figure 60 – Aspect of the panel FLI-2B after have been tested.

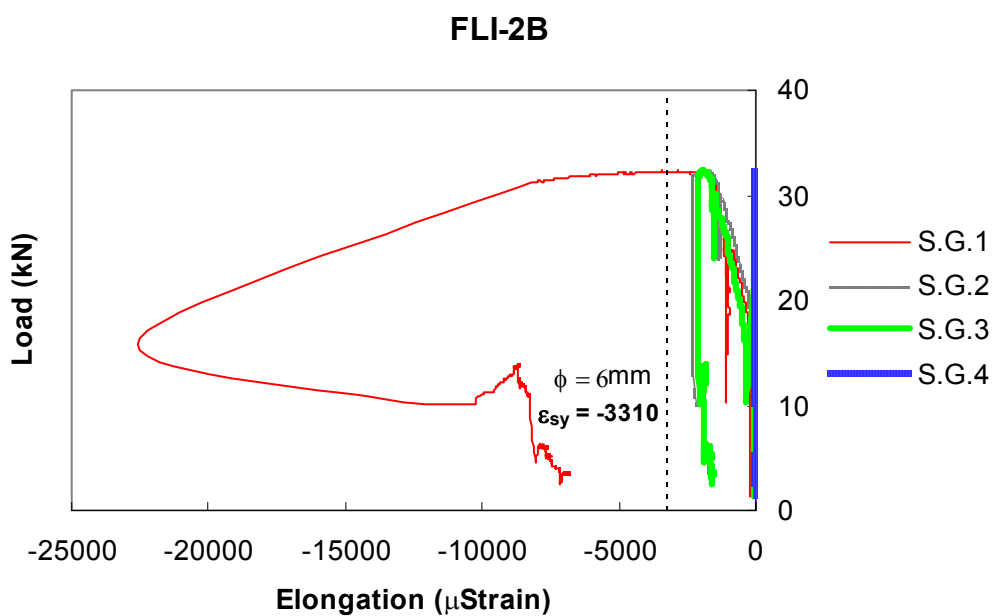
Strain gauge 1, see model 2 in Figure 9, revealed that yielding of steel bar initiated at a load of 32 kN, see Figure 61.

Figure 61 – Force-strain relationship for all strain gauges.

During the fracture process, fissures 1 and 3 were mandatory. However, at a peak load fissure 1 became the main failure crack and fissure 3 entered into closing process, inducing a decrease in the strain of the bar where S.G.1 was glued. The strain evolution registered by the strain gauges placed at panel mid span (near fissure 3), S.G.1, S.G.2 and S.G.3, indicates that the crack opening profile of fissure 3 was not homogeneous at panel width. Larger crack opening occurred at panel front side.

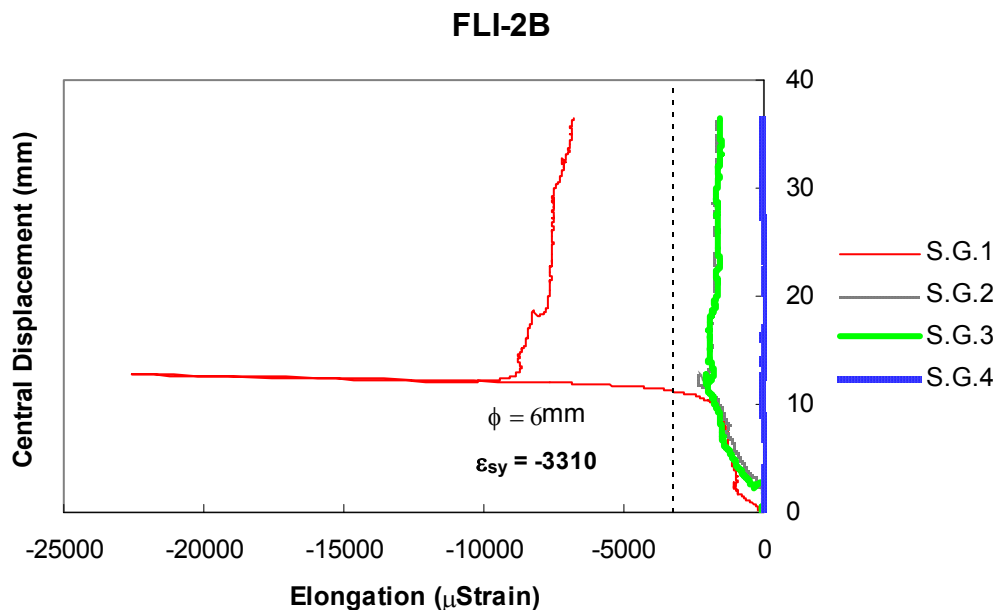
Figure 62 - Relationship between the deflection at panel mid span and the strains at strain gauges.

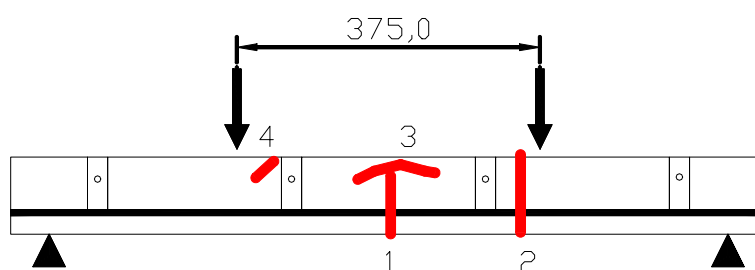
Final crack pattern is represented in Figure 63. First crack (fissure 1) occurred at panel mid span for a load level of about 20 kN, followed by a drop on the panel load bearing capacity. Second fissure appeared at a load of 25 kN, just at left of the right line load. The crack opening procedure of fissure 2 was slower than of fissure 1. At a load level of 28 kN, ahead of fissure 1, an horizontal fissure was formed (fissure 3) due to the high compression horizontal stresses. During the crack opening process of the failure crack (fissure 1), wires of the mesh crossing this crack have ruptured, leading to the drops on the leading, that can be observed on the structural softening branch, see Figure 64.

Figure 63 – Crack pattern in FLI-3B.

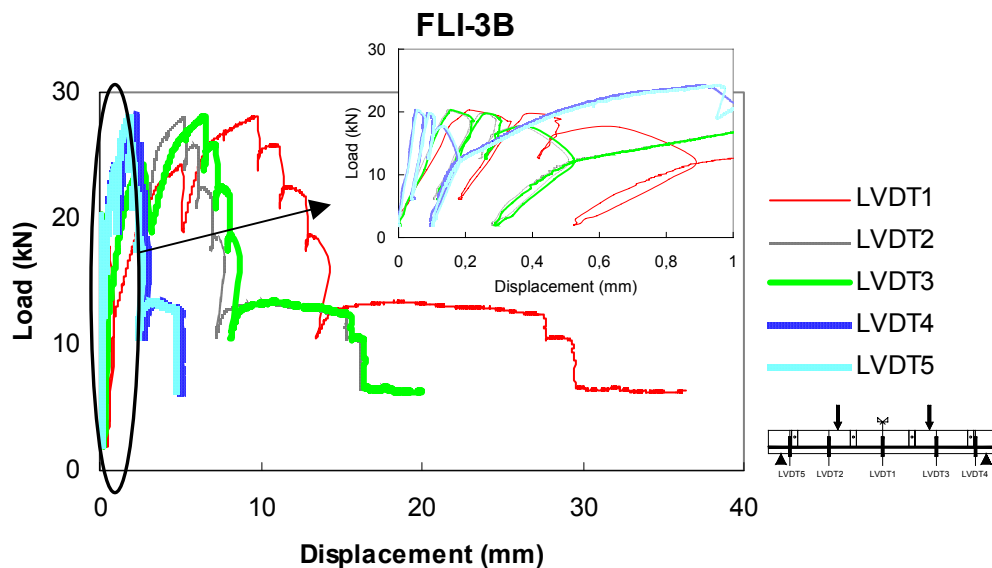
Figure 64 - Force-displacements relationship for all LVDTs.

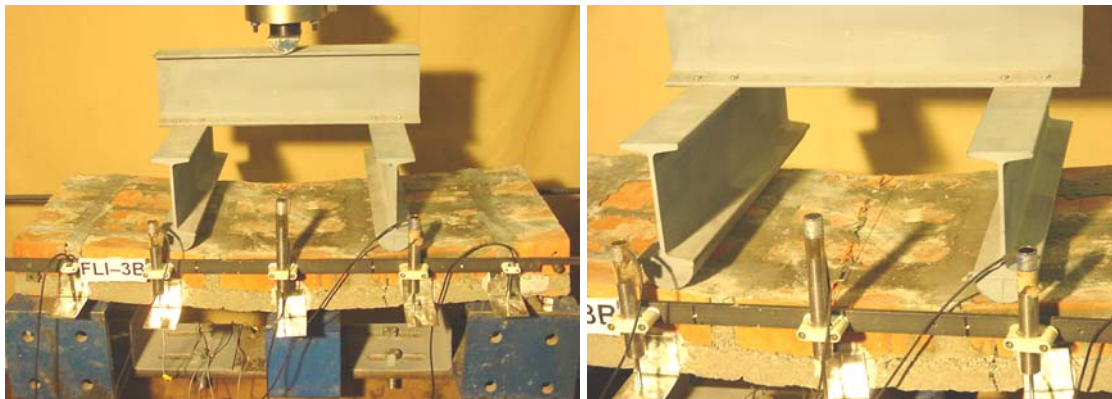
Crushing in the bricks was visible at a load of 13 kN. At the end of the test the panel failure configuration is shown in Figure 65.

Figure 65 – Aspect of the panel FLI-3B after have been tested.

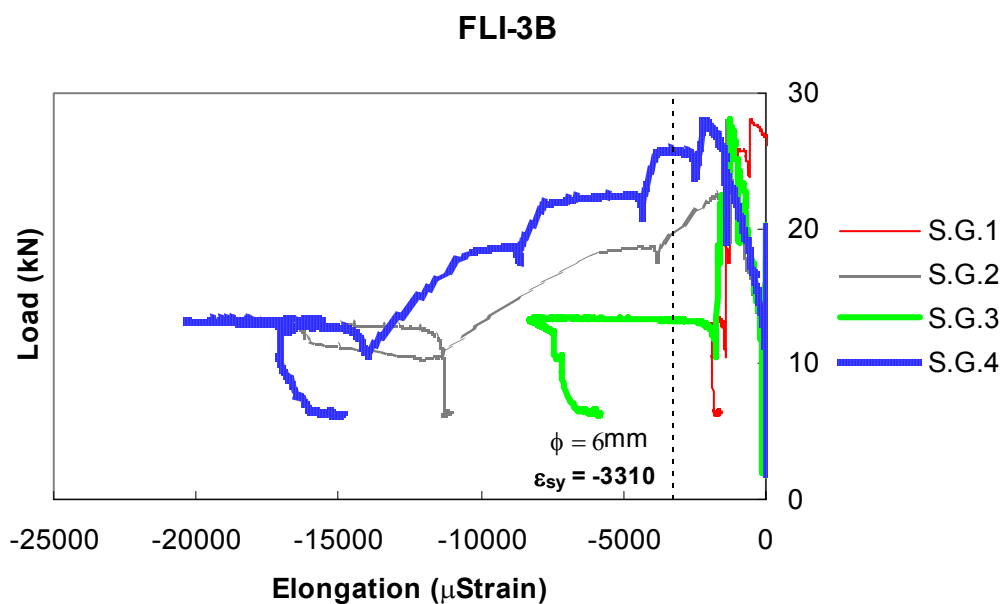
Panel FLI-3B was monitored with the strain gauges arrangement of model 3 of Figure 9. According to Figures 66 and 67, the bars began yielding just before panel has entered in the structural softening. The bars corresponding to S.G.4 and S.G.2 have first yielded, followed by bar of S.G.3, revealing that the crack opening of the failure crack was larger at panel extremities than at its center.

Figure 66 - Force-strain relationship for all strain gauges.

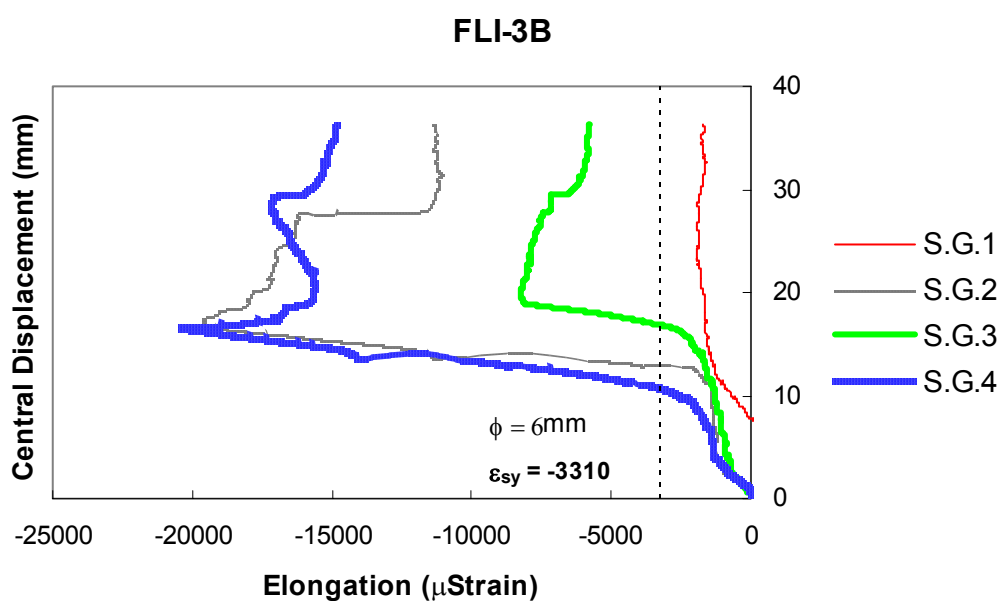
Figure 67 - Relationship between the deflection at panel mid span and the strains at strain gauges.

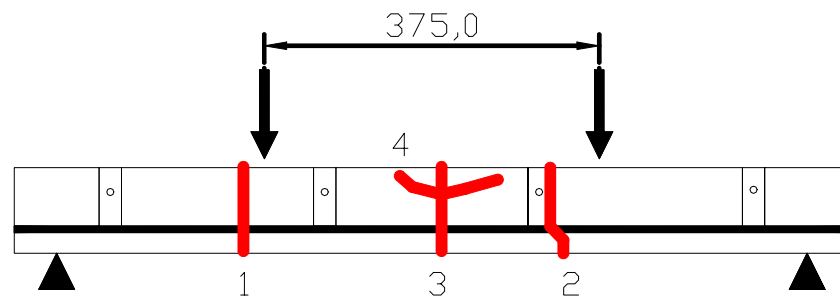
The behavior of this panel was quite similar of the previous one. At a load of about 20 kN fissure 1 was observed just at left of left line load, see Figures 68 and 69.

For a load slightly higher than 20 kN fissure 2 was formed. At a load level of 24 kN occurred fissure 3 and finally horizontal fissure 4 was arisen at a load of about 30 kN. At this load level, some wires of the mesh were ruptured at the crack surface of fissure 3, and the panel entered in structural softening, having the load bearing capacity decreased to a load level of 12 kN. For this load level and during the deflection evolution, the brick volume in the alignment of fissure 3 and above fissure 4, was crushed, see Figure 70.

Figure 68 – Crack pattern in FLI-4B.

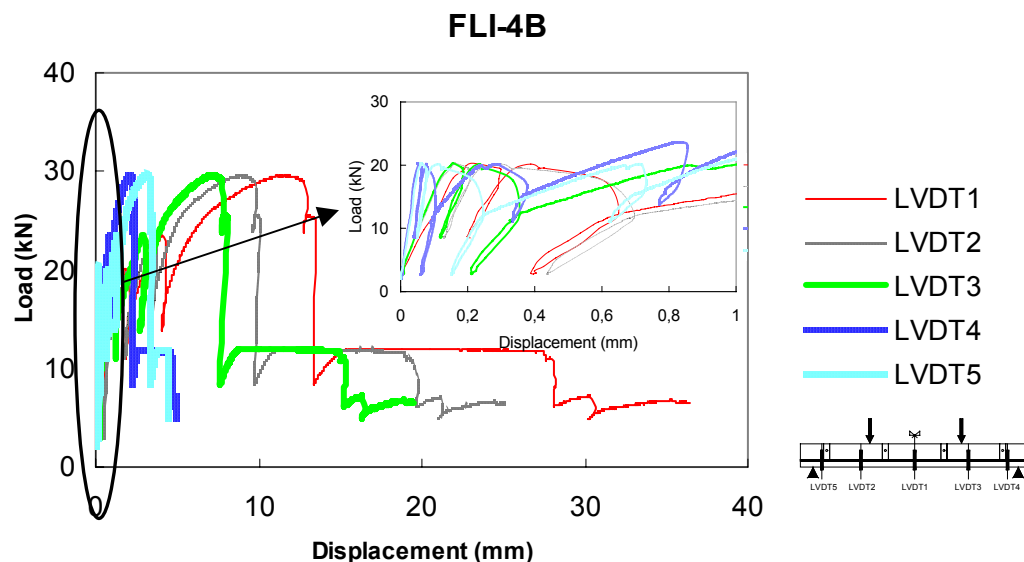
Figure 69 - Force-displacements relationship for all LVDTs.

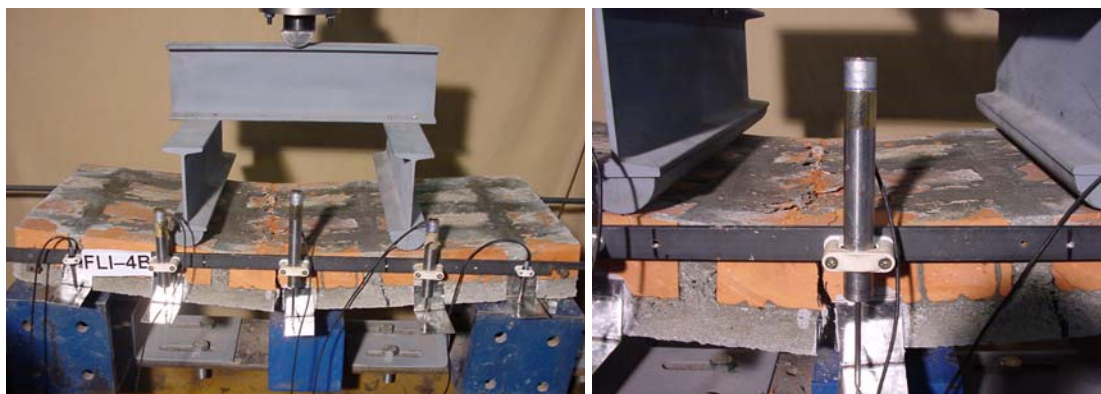
At the end of panel test, fissure 3 had a crack opening of 10 mm and 5 mm at panel bottom surface and at concrete layer/brick interface, respectively.

Figure 70 – Aspect of the panel FLI-4B after have been tested.

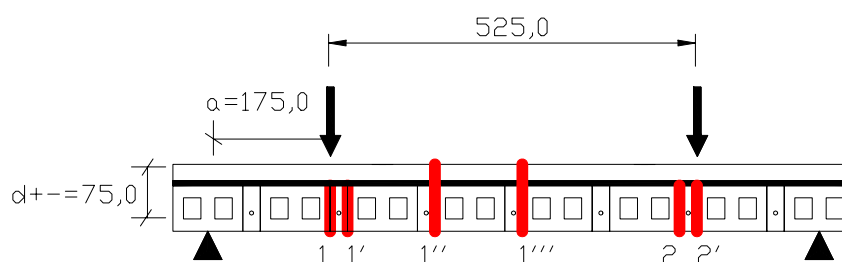
Fissures 1, 1', 1'' and 1''' appeared simultaneously at a load of about 55 kN, and all of them started at joint/brick interface, see Figure 72. The maximum load bearing capacity of the panel was 74 kN, that was attained when fissures 2 and 2' were formed. After that, the panel entered in structural softening. In spite of the reduced value of the shear span ratio ( $a/d \approx 175/75 \approx 2.3$ ) no shear cracks were visible.

Figure 71 – Crack pattern in FLC-1A.

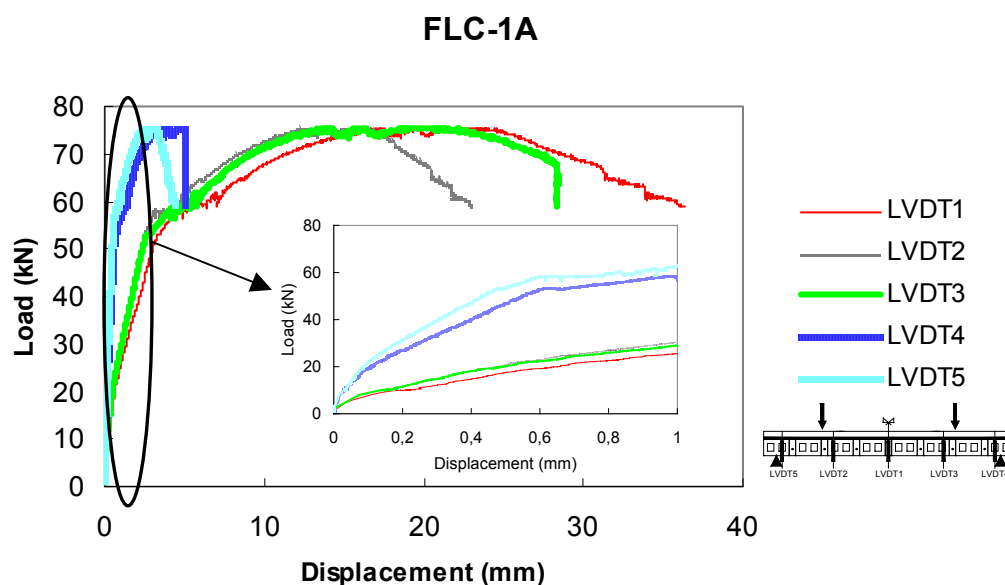
This panel showed a very ductile behavior. The test was interrupted when LVDT placed at panel mid span measured a deflection larger than 35 mm. As crack pattern was practically symmetric, the displacements registered by LVDTs positioned symmetrically were similar, see Figure 72. The panel failure configuration at the end of the test is shown in Figure 73. The largest crack opening was measured in fissure 2', having 8 mm and 4 mm at panel bottom surface and at brick-concrete concrete layer

Figure 72 - Force-displacements relationship for all LVDTs.

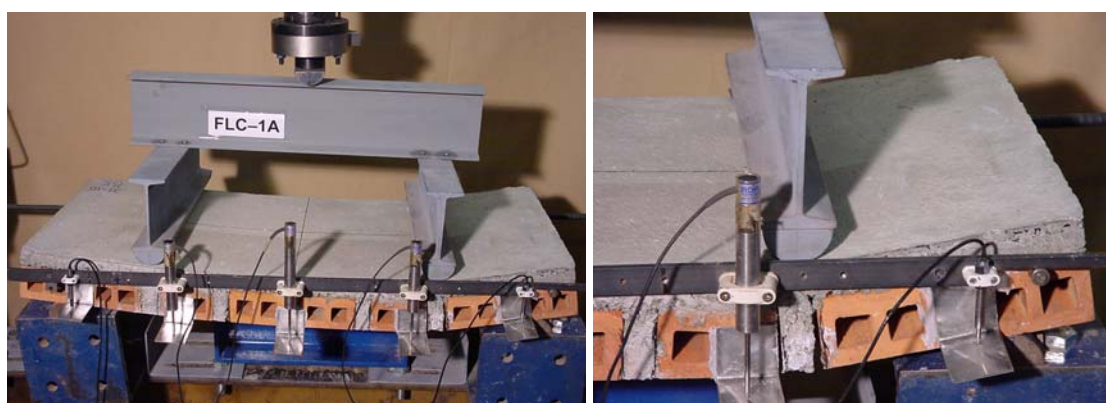
interface, respectively. For this deformation, fissure 2 had a crack opening of 7 mm and 1 mm at the aforementioned levels.

Figure 73 – Aspect of the panel FLC-1A after have been tested.

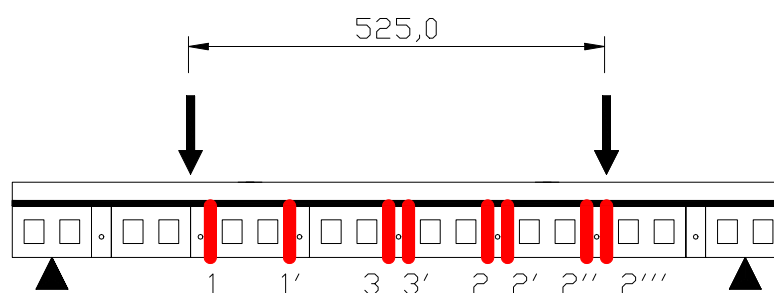
This panel showed a behavior very similar to the one of the panel FLC-1A, as Figures 74 and 77 reveal. The final crack pattern of panel FLC-2A is represented in Figure 74. Up to a load level of 55 kN no fissure was visible. At a load of about 60 kN fissures 1 and 1' were formed simultaneously and at 70 kN occurred fissures 2, 2', 2'' and 2''''. Fissures 3 and 3' arose at a load of 72 kN. Between the first and last crack formation, the panel developed large deflection with a very ductile behavior. When the

Figure 74 – Crack pattern in FLC-2A.

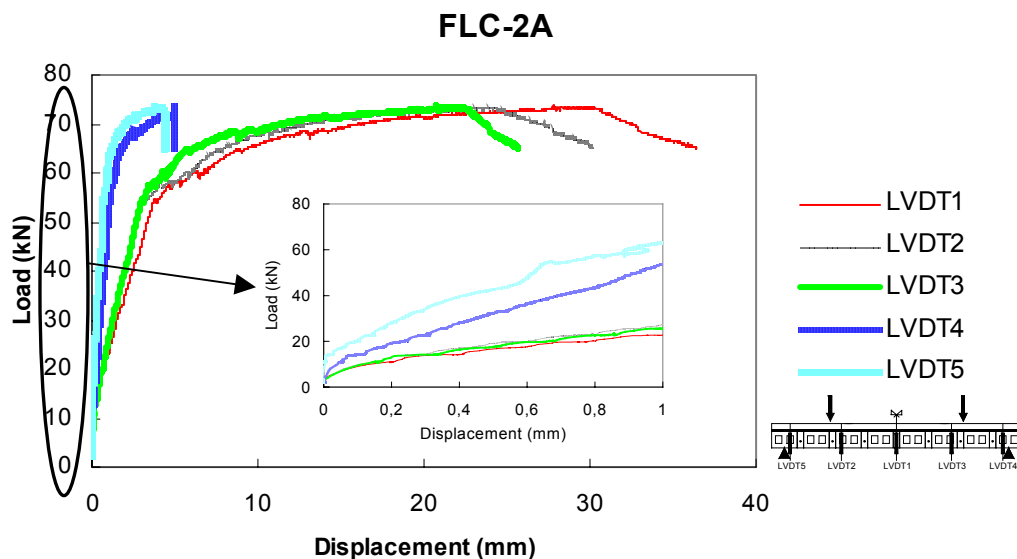
As Figure 75 shows, the LVDTs placed in the "pure bending zone" have registered similar deflections values. Since crack pattern was quasi-symmetrical, the panel deformability was almost symmetrical.

Figure 75 - Force-displacements relationship for all LVDTs.

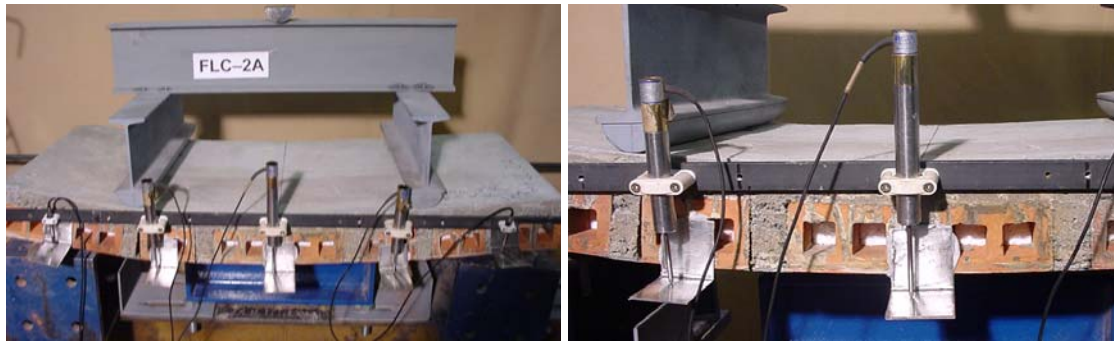
test was interrupted, the maximum deflection was 36 mm and the panel sustained a load of 65 kN. The photos included in Figure 76 show that, at the end of the test, fissure 1 was the most wide. At panel front face this fissure had a crack opening of 10 mm and 3 mm at panel bottom surface and at brick/concrete layer interface, while at panel rear face values of 3 mm and 1 mm were measured.

Figure 76 – Aspect of the panel FLC-2A after have been tested.

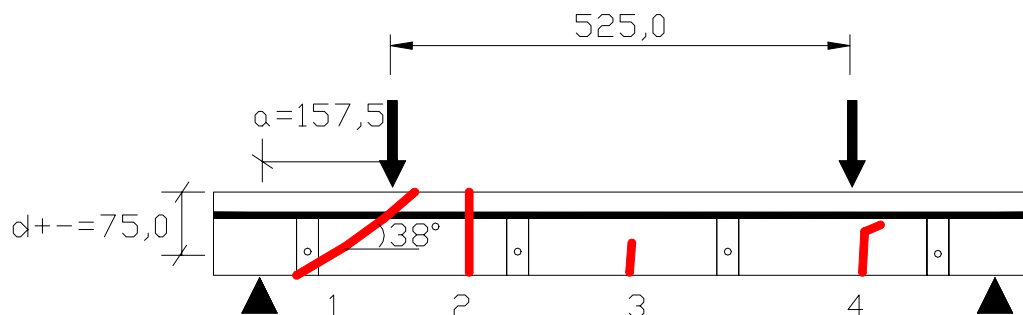
Fissure 1 was the first one to occur, and was formed at a load level of about 25 kN crossing the brick, at the panel left shear span. Fissure 2 occurred at a load of about 40 kN and appeared in the same brick, but in between line loads. The remaining fissures were formed at a load level of 47 kN. Before have attained the concrete layer, fissure 1 changed from vertical to inclined direction ( $\alpha \approx 38^\circ$ ), see Figure 77.

Figure 77 – Crack pattern in FLC-1B.

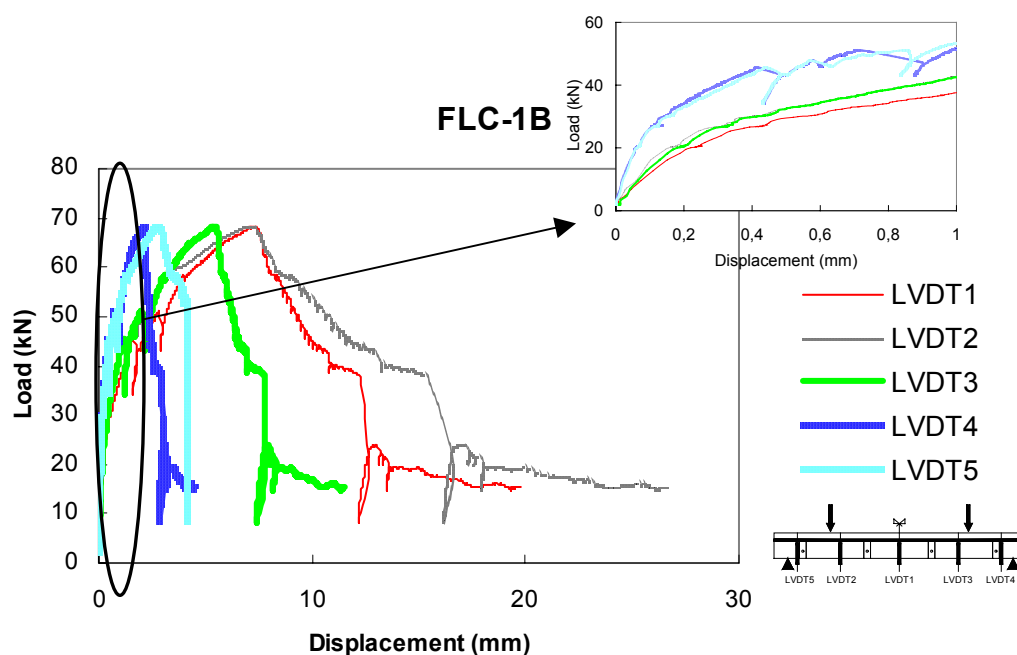
Figure 78 - Force-displacements relationship for all LVDTs.

Due to excessive rotation of the part of the panel at left of the failure crack, the LVDT 5 exceeded its measuring length when registering a deflection of about 4.2 mm and, consequently, the measuring process of this LVDT was interrupted.

The panel was failed by shear, see Figure 79, in a very brittle way. As failure shear crack was developed at panel left shear span, the LVDTs positioned at panel left side have registered larger displacements than the corresponding ones at panel right side, see Figure 78.

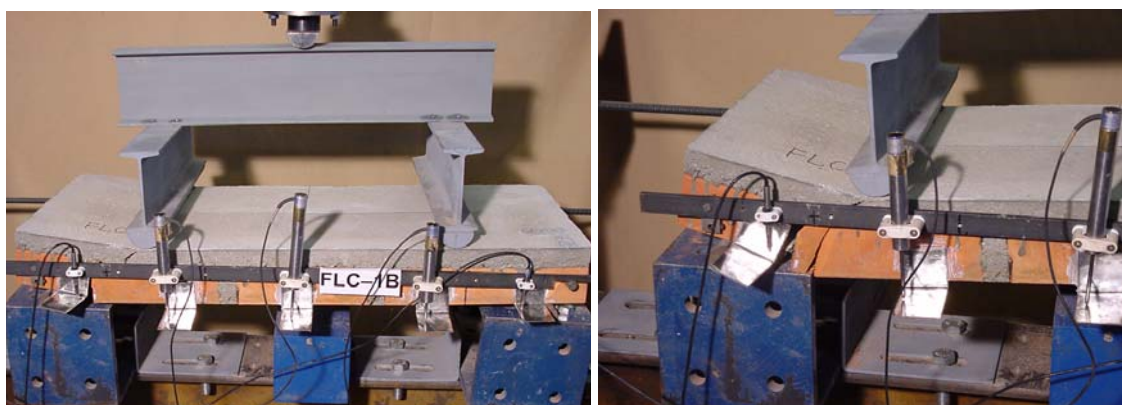
Figure 79 – Aspect of the panel FLC-1B after have been tested.
